Office of Border Public Health

February 9, 2022

Naegleria fowleri in Public Interactive Water Features and Fountains

Texas Department of State
Health Services

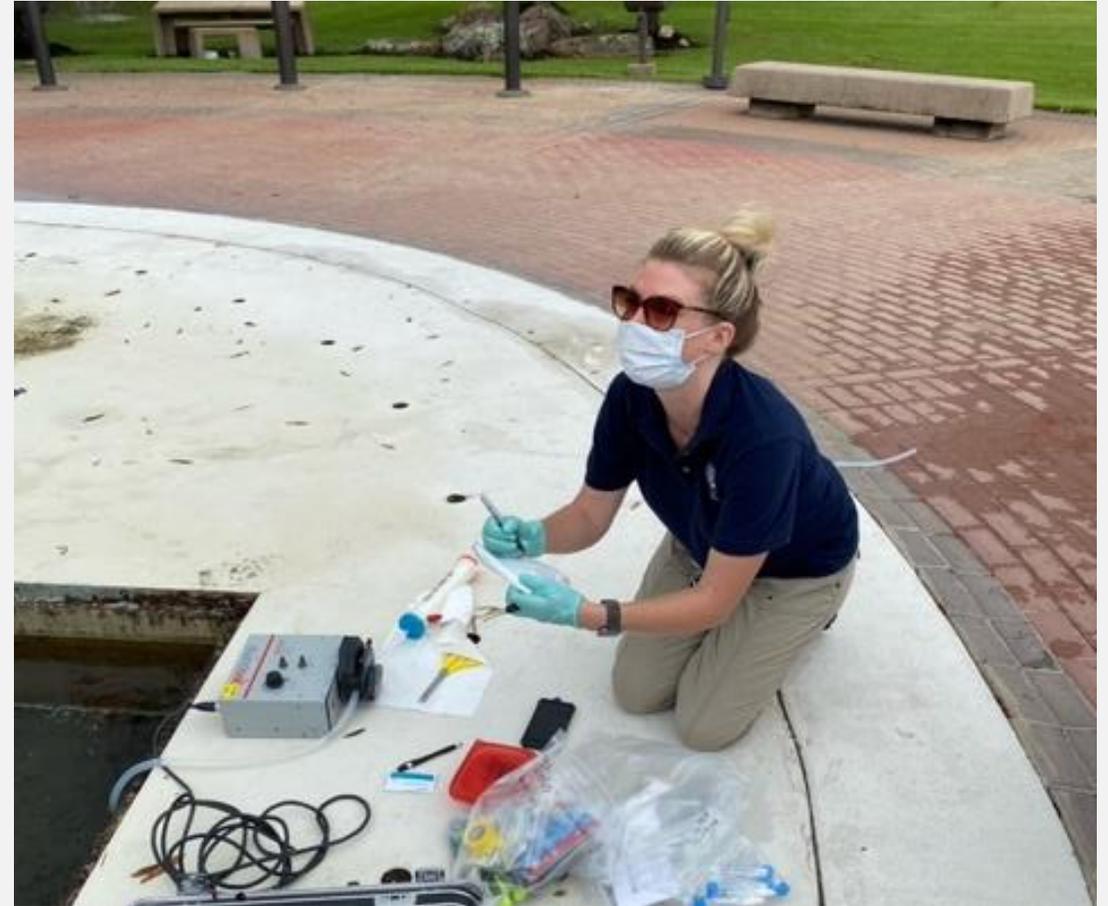
Lake Jackson, Texas

- Becky Coonrad, RS, from Region 5 assisted in the investigation by taking samples at several locations for analysis by the CDC.
- The samples taken from **several** locations including the home outside hose bib, the splash pad storage tank and the fire hydrant downstream from the splash pad.
- All samples were positive with the highest concentration found in the splash pad storage tank.

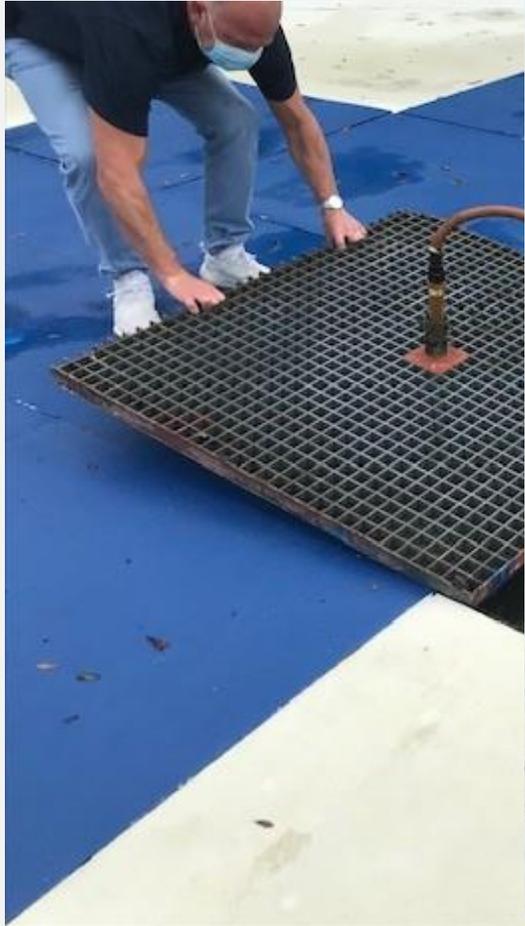
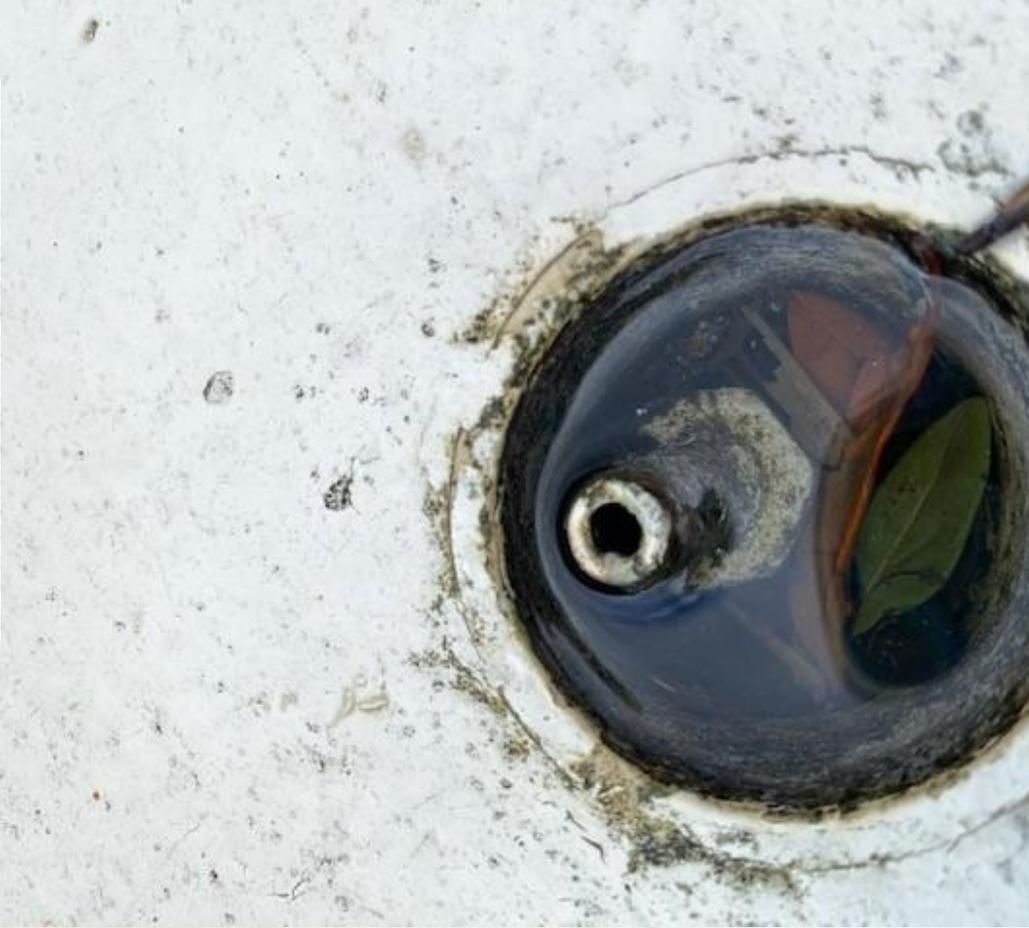
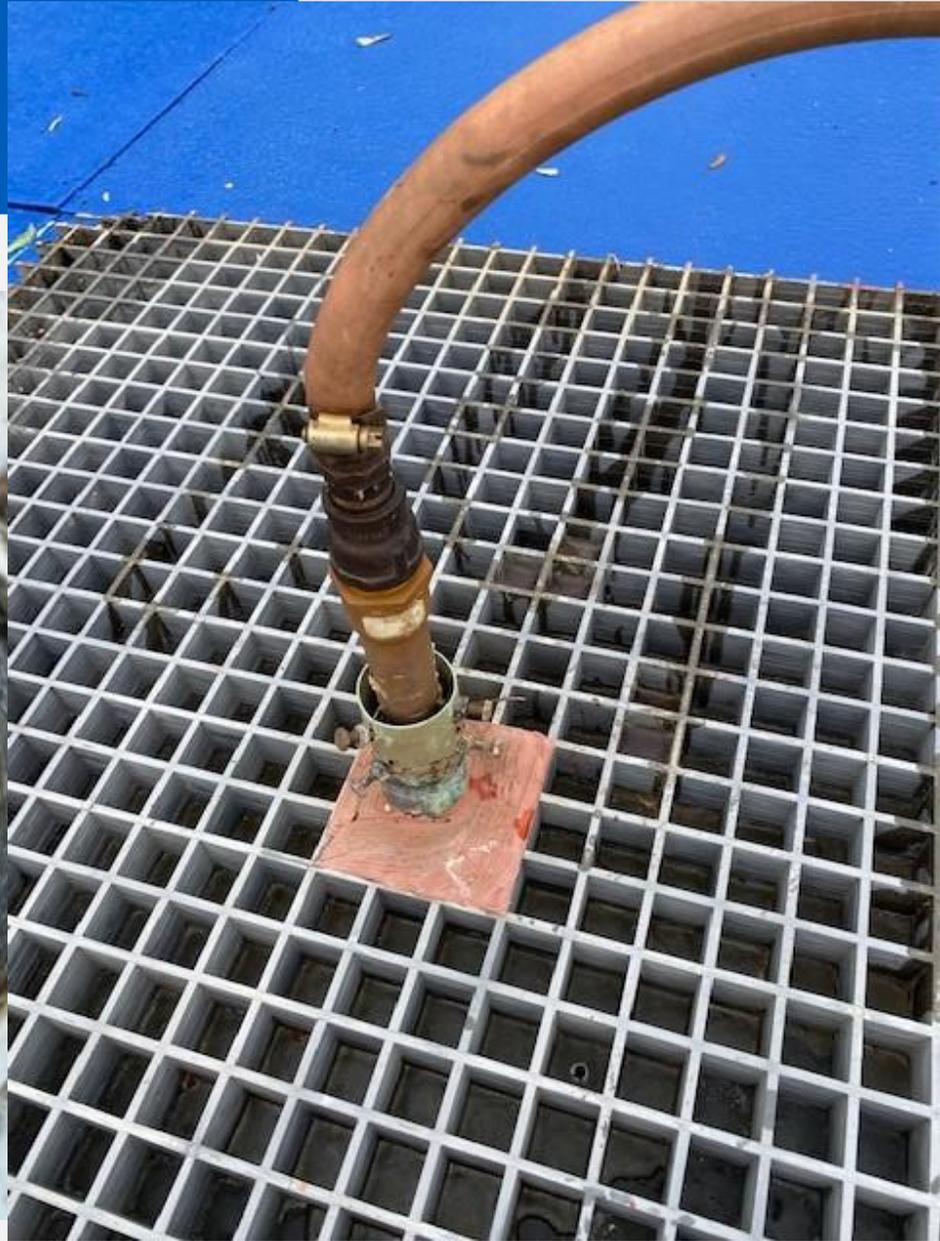
Lake Jackson, Texas

- The spray/splash pad was a single water use aquatic attraction. The water was delivered from the municipal supply to the spray/splash pad for use and then was discharged to waste.
- There was no water filtration or sanitization system at the spray/splash pad because the water was not reused.
- There was no backflow preventer installed on the water supply to the spray/splash pad.
- The City of LJ initiated chlorine burn protocols to disinfect the entire city water supply and established a protocol for routine maintenance of the water distribution system.
- The spray/splash pad has been removed and replaced by a park.

- Due to the unique nature of spray/splash pads, a maintenance plan consisting of routine and thorough cleaning and disinfection of spray/splash pad circulation equipment, storage tanks, deck area, and nozzles of the spray equipment should be developed and implemented.

- Storm water must be diverted away from the circulation system and not be allowed to mingle with water in the circulation system or to stand in passive drainage systems.

- Routine water quality should be tested on a daily basis, whether single use or recirculated, and monitored, and results recorded in logs.
